TEST REPORT #213041B, REVISION 1.1

VITA 46 VPX CONNECTORS

QUALIFICATION

HYPERTRONICS CORPORATION

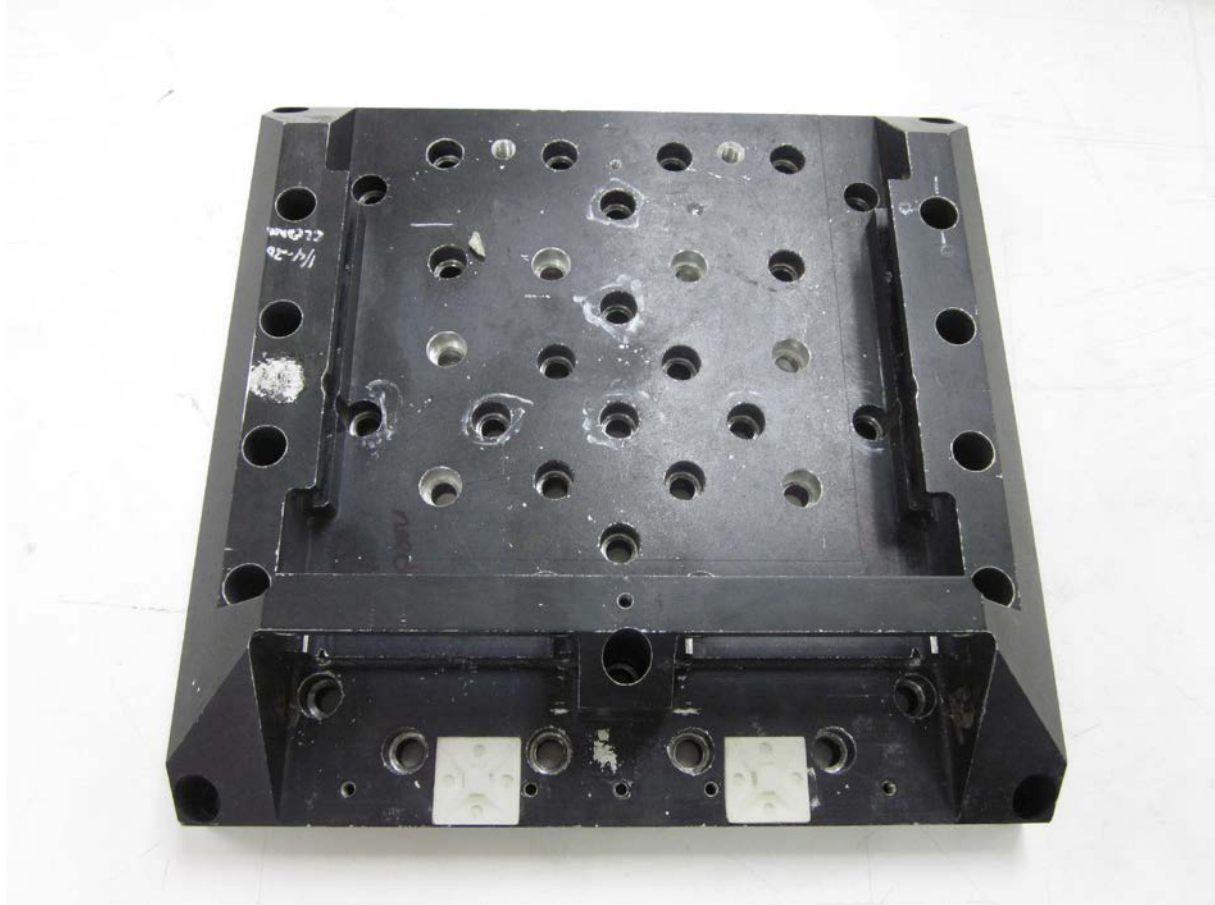
**FIGURE #1**

MECHANICAL SHOCK/VIBRATION TEST FIXTURE

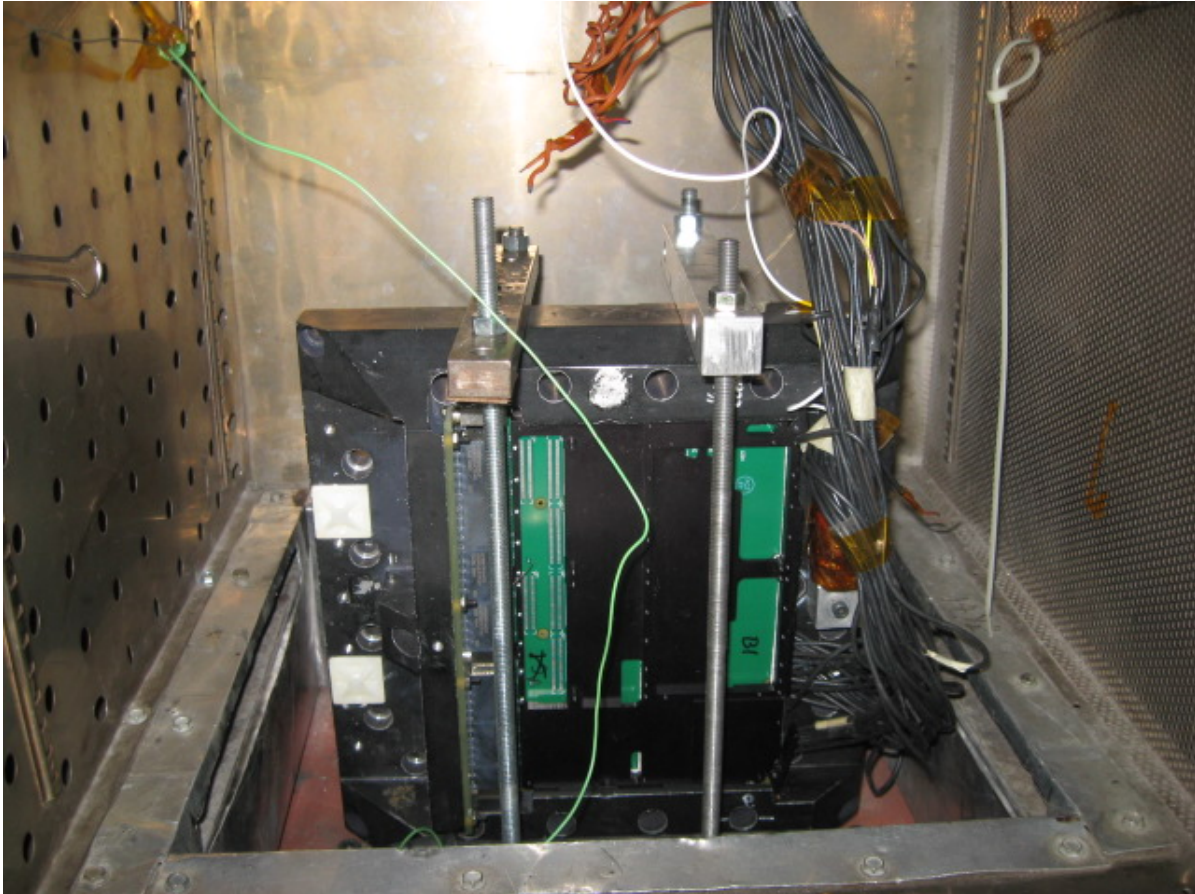
**FIGURE #81**

RANDOM VIBRATION @ TEMPERATURE CYCLE

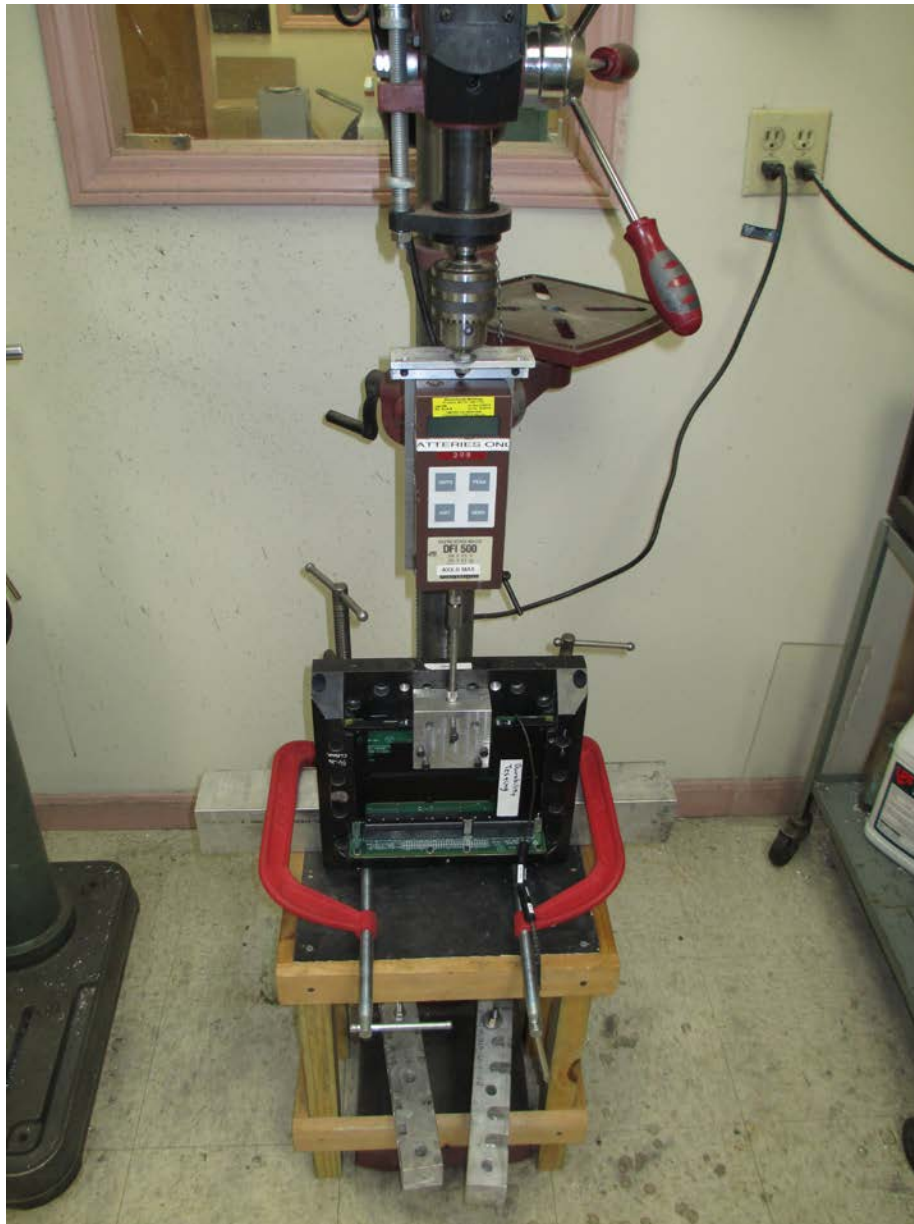
**FIGURE #86**

**MATING FORCE**
